**Hewlett Packard**  
Enterprise

# 5140HI-CMW710-R6823 Release Notes

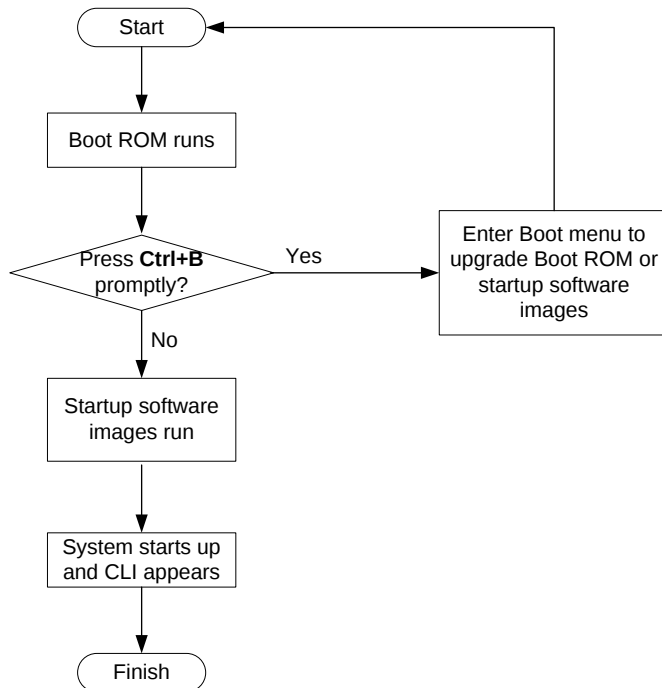
**Figure 1 System startup process**

Upon power-on, the Boot ROM image runs to initialize hardware and then the software images run to start up the entire system, as shown in [Figure 1](#).

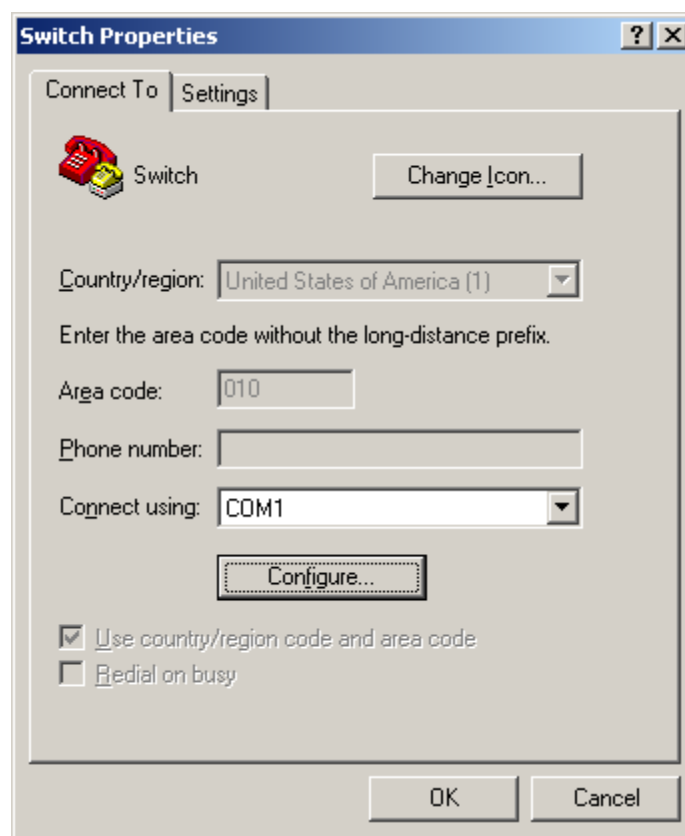
**Figure 3 Properties dialog box**

- b. Select **File > Properties**, and in the **Properties** dialog box, click **Configure**.

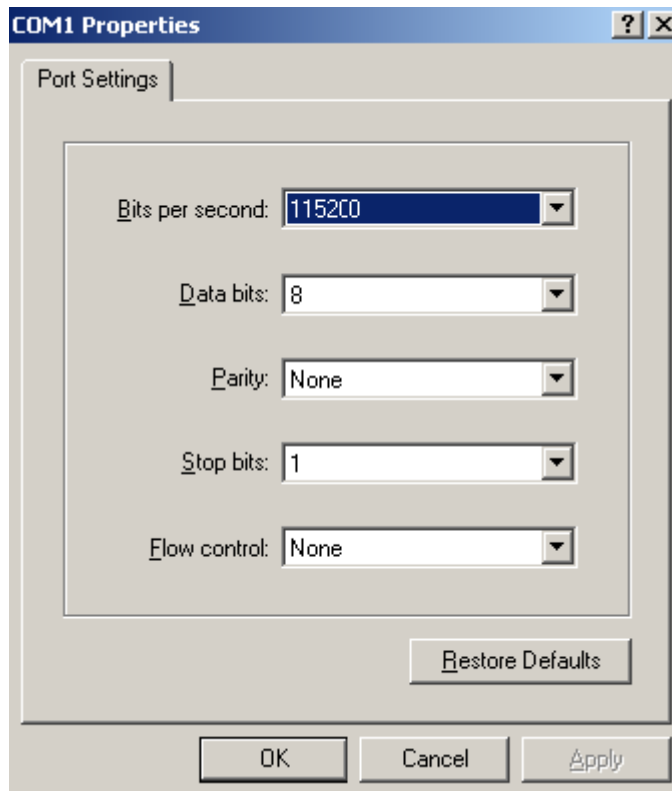
Figure 4 Modifying the baud rate

- c. Select **115200** from the **Bits per second** list and click **OK**.

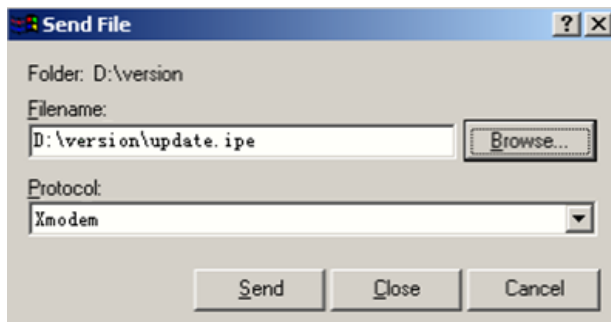
**Figure 7 File transmission dialog box**

8. In the dialog box that appears, click **Browse** to select the source file, and select **Xmodem** from the **Protocol** list.

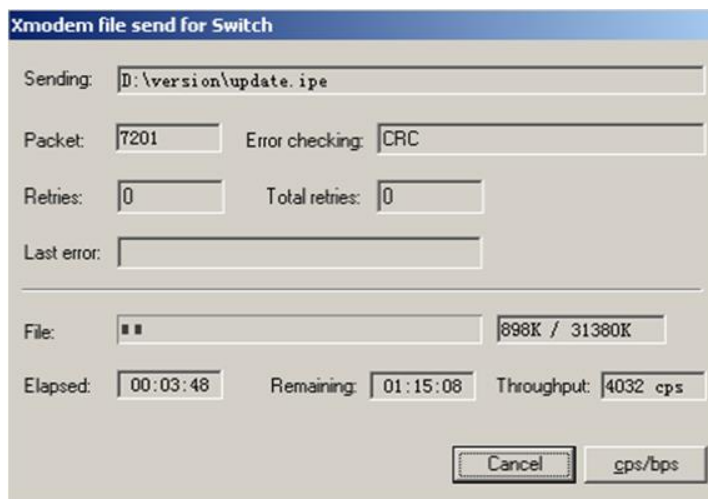
**Figure 8 File transfer progress**

9. Click **Send**. The following dialog box appears:

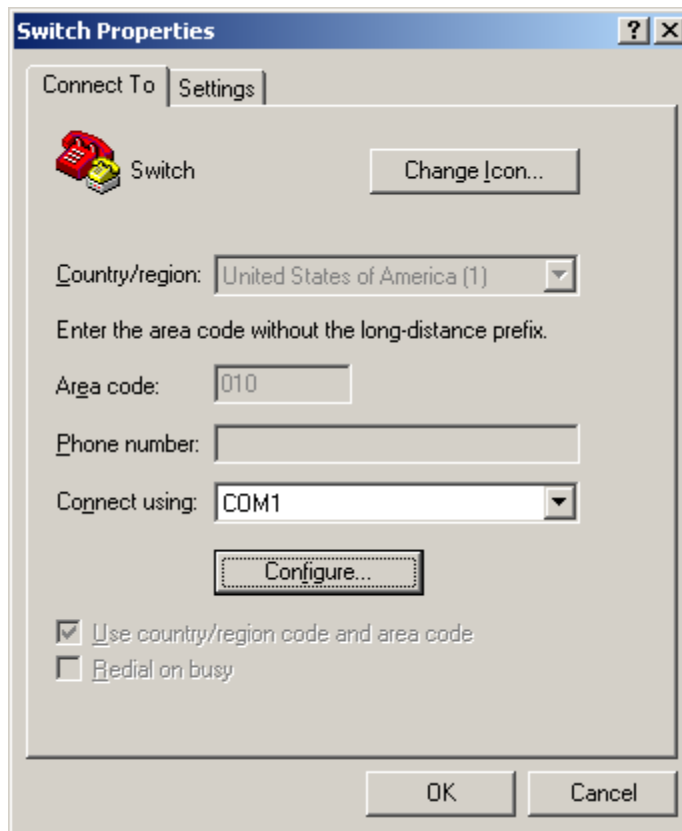
**Figure 10 Properties dialog box**

- b. Select **File > Properties**, and in the **Properties** dialog box, click **Configure**.

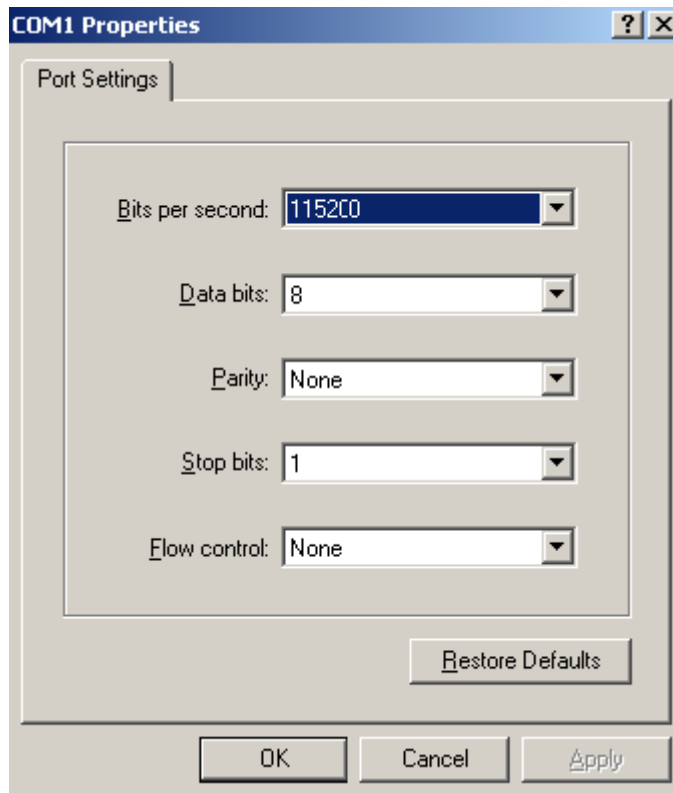
Figure 11 Modifying the baud rate

- c. Select **115200** from the **Bits per second** list and click **OK**.

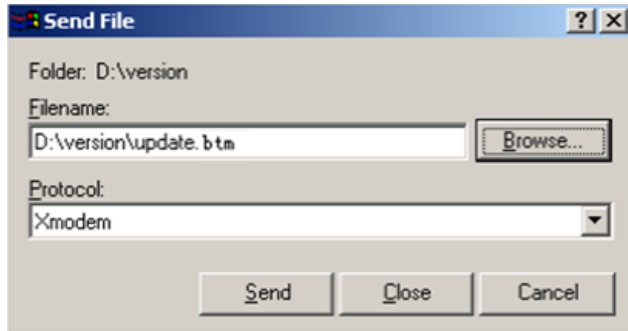
**Figure 14 File transmission dialog box**

8. In the dialog box that appears, click **Browse** to select the source file, and select **Xmodem** from the **Protocol** list.

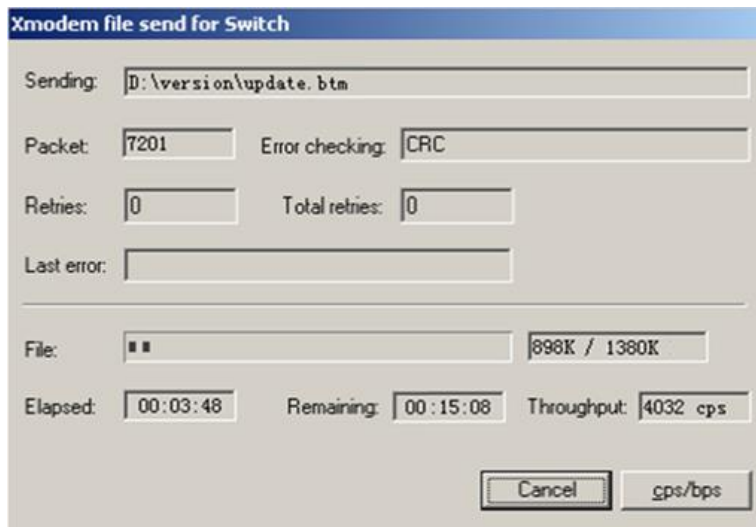
**Figure 15 File transfer progress**

9. Click **Send**. The following dialog box appears:

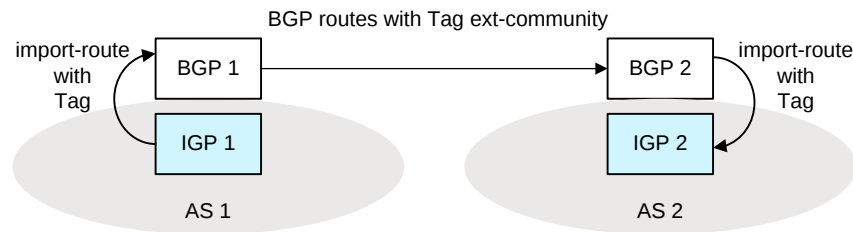
**Figure 1 Distributing route tag information**

Route tag information is distributed across ASs as shown in Figure 1.

1. In the source AS, the network administrator redistributes IGP routes to BGP and enables BGP to inherit IGP route tags. To have BGP inherit IGP route tags, use one of the following methods:

- Execute the **import-route** command with the **inherit-tag** keyword specified. BGP will directly inherit the original tags of redistributed IGP routes.
