# HPE OfficeConnect 1920 Switch Series CMW520-R1119 Release Notes

This document describes the features, restrictions and guidelines, open problems, and workarounds for version CMW520-R1119. Before you use this version in a live network, back up the configuration and test the version to avoid software upgrade affecting your live network.

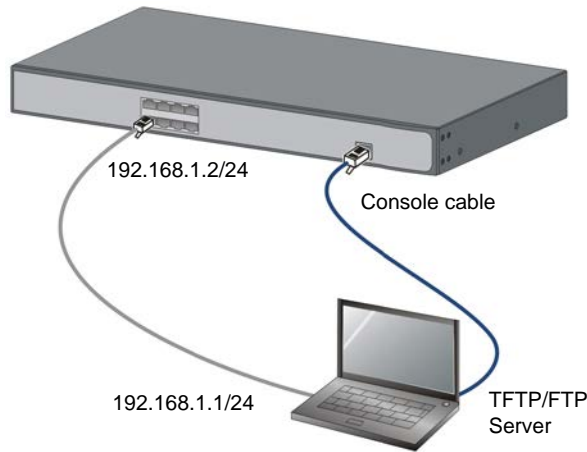
**Figure 1 Set up the upgrade environment**

- Set up the upgrade environment as shown in [Table 8](#).
- Configure switch to make sure that the switch and the file server can reach each other.
- Run a TFTP or FTP server on the file server.
- Log in to the CLI of the switch through the console port.
- Copy the upgrade file to the file server and correctly set the working directory on the TFTP or FTP server.
- Make sure that the upgrade has minimal impact on the network services. During the upgrade, the switch cannot provide any services.

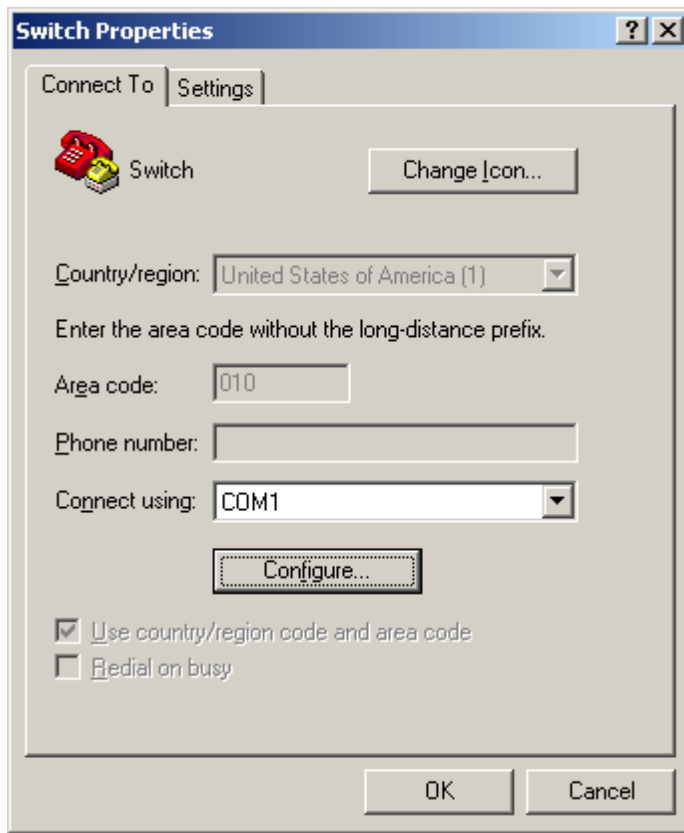
**Figure 4 Properties dialog box**

5. Select **File > Properties**, and in the **Properties** dialog box, click **Configure**.

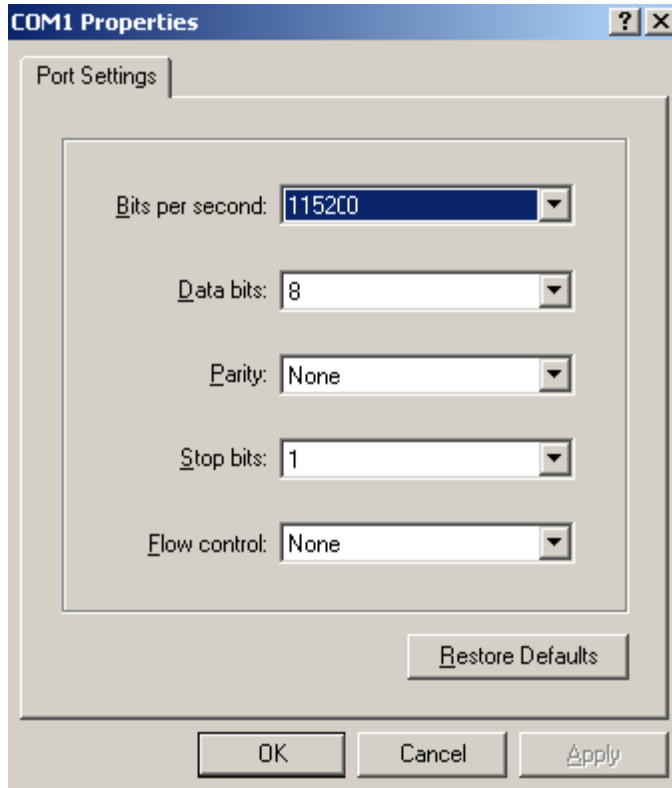
**Figure 5 Modify the baud rate**

6. Select **115200** from the **Bits per second** list and click **OK**.

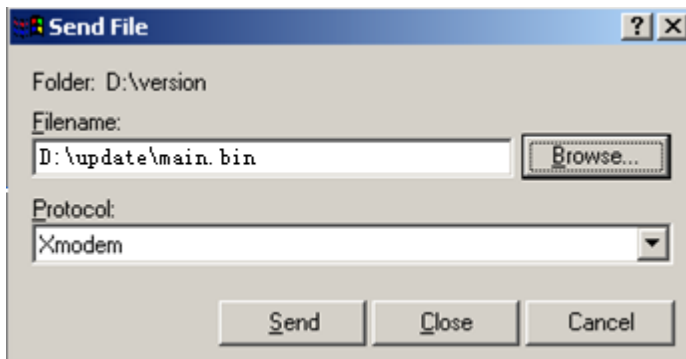
**Figure 8 File transmission dialog box**

12. In the dialog box that appears, click **Browse** to select the source file, and select **Xmodem** from the **Protocol** list.
